**Re: Compliance Evaluation Inspection
Guánica Wastewater Treatment Plant
NPDES Permit Number PR0020486**

COMPLIANCE EVALUATION INSPECTION

Facility Name: Guánica WWTP
NPDES Permit Number: PR0020486
PRASA Representative: Amalio Quirós, Plant Operator

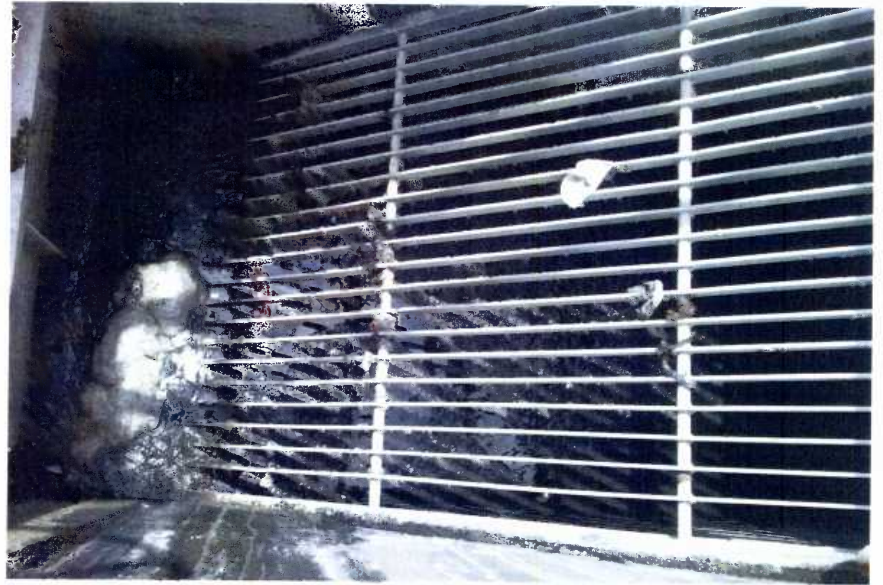
- The plant has two entrance channels: one channel has a bar screen, and the other channel has a comminutor.
- The entrance channel with the bar screen is used when the comminutor goes out of service. At the time of the CEI, the bar screen was not in use. But it had solids and plastic materials, as seen in Figure # 1 attached.
- The comminutor was in operation at the time of the CEI.

Bar screen.

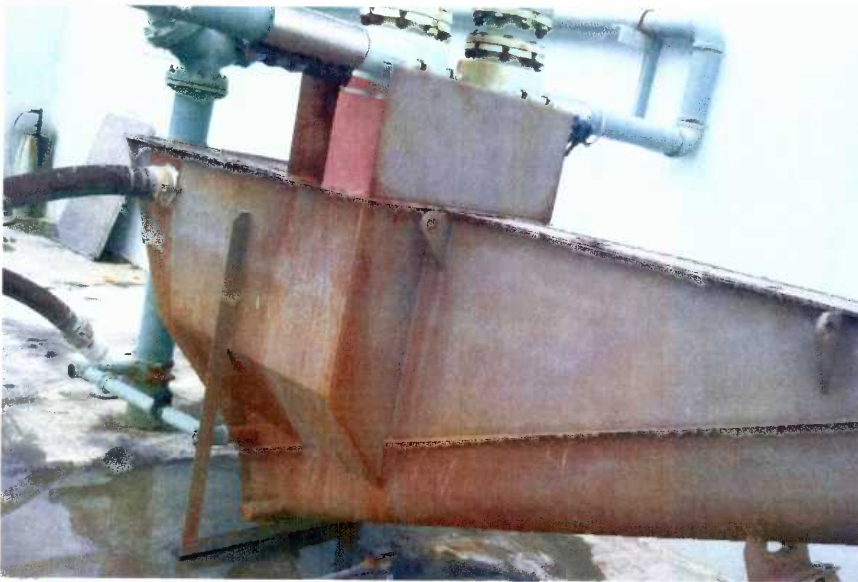
service at the time of the CEI. The screw conveyor was corroded, as seen in Figure # 2 attached. Form AAA-340-A # 15558 (10075359) was completed on October 26, 2011.

Screw conveyor.

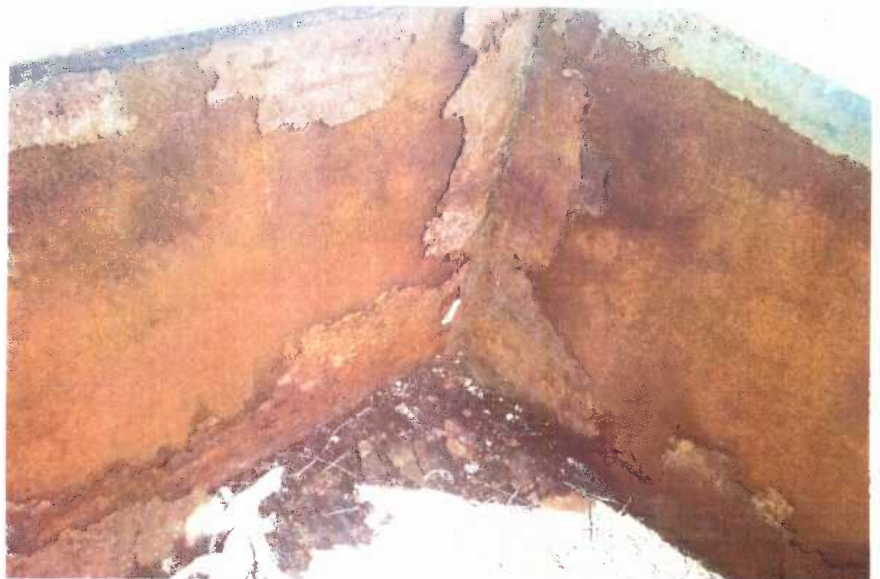
- The collection bin for the screw conveyor was also corroded, as seen in Figure # 3 attached.

Collection bin for the
screw conveyor.

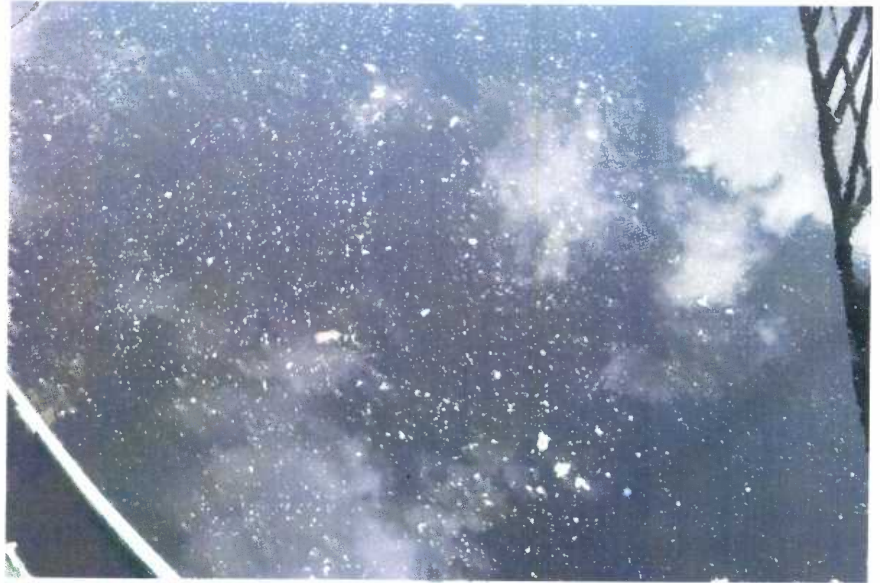
- Filamentous organisms were observed at the surface of the clarifier, as seen in Figure # 4 attached.
- Short-circuiting was observed at the "V-type" effluent weirs of the clarifier, as seen in Figure # 5 attached.
- Floatables and scum were observed at the clarifier's center well or inner baffle, as seen in Figure # 6 attached.
- The air piping had an air leak at one of its joints.
- Solids accumulation was observed at the surface of the digester, as seen in Figure # 7 attached.
- There are three (3) blowers. Only one (1) blower is needed to provide aeration. Unit # 3 was in operation. Units # 1 and # 2 were in stand-by mode, but operable. Work Order # 10093591 was completed on March 27, 2012; their filters do not match.

Clarifier's surface.

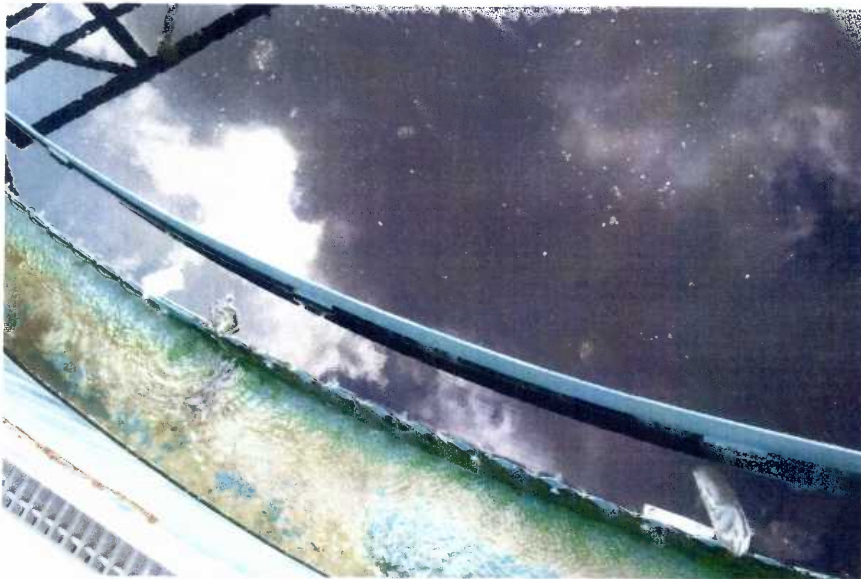
Figure # 5

Clarifier's "V-type"
effluent weirs.

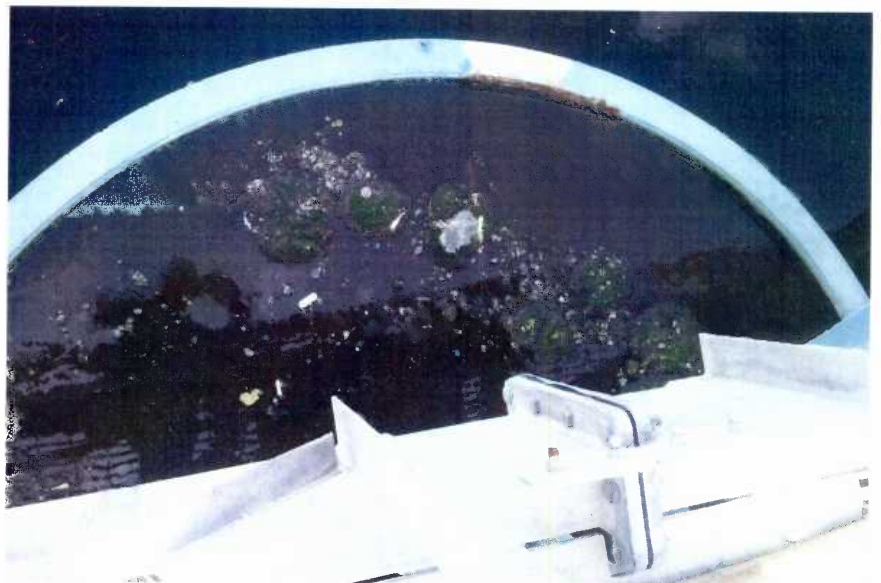
Figure # 6

Clarifier's center
well or inner baffle.

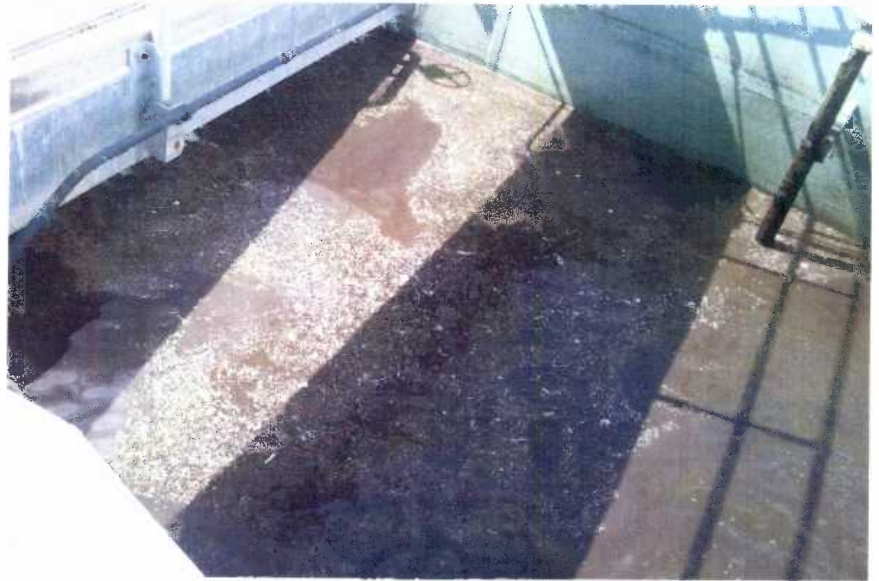
Figure # 7

Sludge digester.

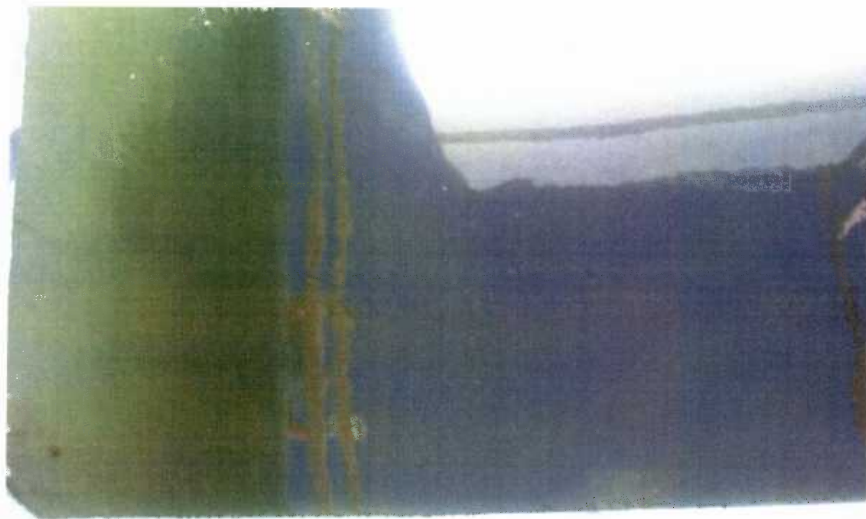
- There are three (3) chlorine contact chambers at the facility. All units were in operation at the time of the CEI.
- The surface of the chlorine contact chamber had some floatables, and its water had a green-like color appearance, as seen in Figure # 8 attached.
- The chlorine inventory at the time of the inspection consisted of four (4) - two thousand gallon pound chlorine cylinders (2,000 lbs): one (1) chlorine cylinder was in use, one (1) chlorine cylinder was empty, and two (2) chlorine cylinders were full.
- The plant has two (2) chlorine leak detectors. When a chlorine leak was simulated, both units did work. These units were calibrated on April 30, 2012.
- The exhaust fan was in operation.
- The two (2) automatic chlorine application devices were in operation. Both units were calibrated on April 30, 2012.

Chlorine contact
chamber.

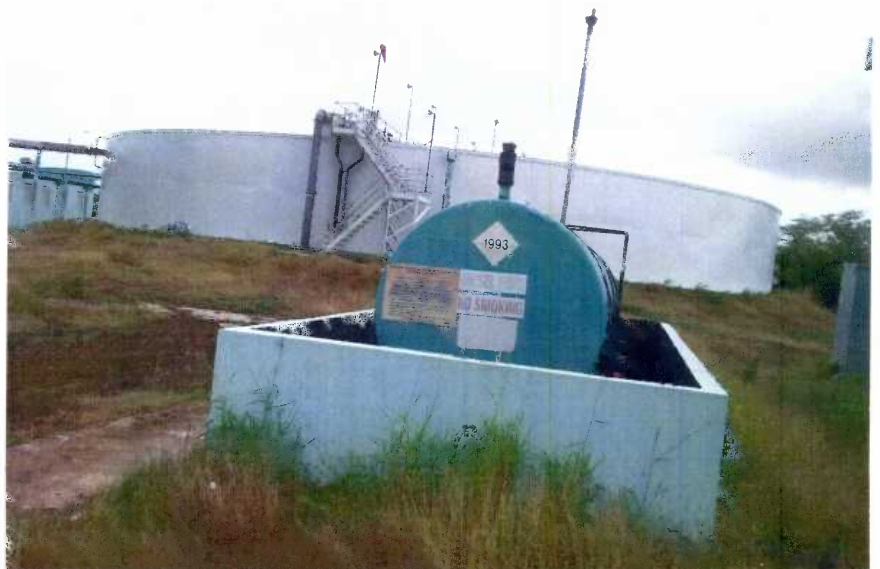
- The facility previously had one (1) APU for the activated sludge package plant with a 500-gallon diesel tank capacity.
- At the time of the CEI, and although the BNR Module was not in operation, its new APU (750 KVA) with a 5,000-gallon diesel tank capacity was in service.
- Figure # 9 attached shows a partial view of the diesel tank for the new APU. The secondary containment system for this unit needs to be cleaned. According to the operator, the diesel level ruler did not work. The operator has not a safe access to the diesel tank.
- The addition of water for the new APU's radiator, results unsafe as well for the operator who

needs to stand on the APU's motor to perform this task. This unit has no stairs or a safe mechanism to access it.

Diesel tank for the
Alternate Power Unit.
